6 PROCEEDINGS OF THE 1980 TRI-SERVICE
CONFERENCE ON CORROSION

5-7 NOVEMBER 1980
US AIR FORCE ACADEMY, COLORADO, Volume I.

CORROSION OF NAVAL SEA SYSTEMS
AN OVERVIEW

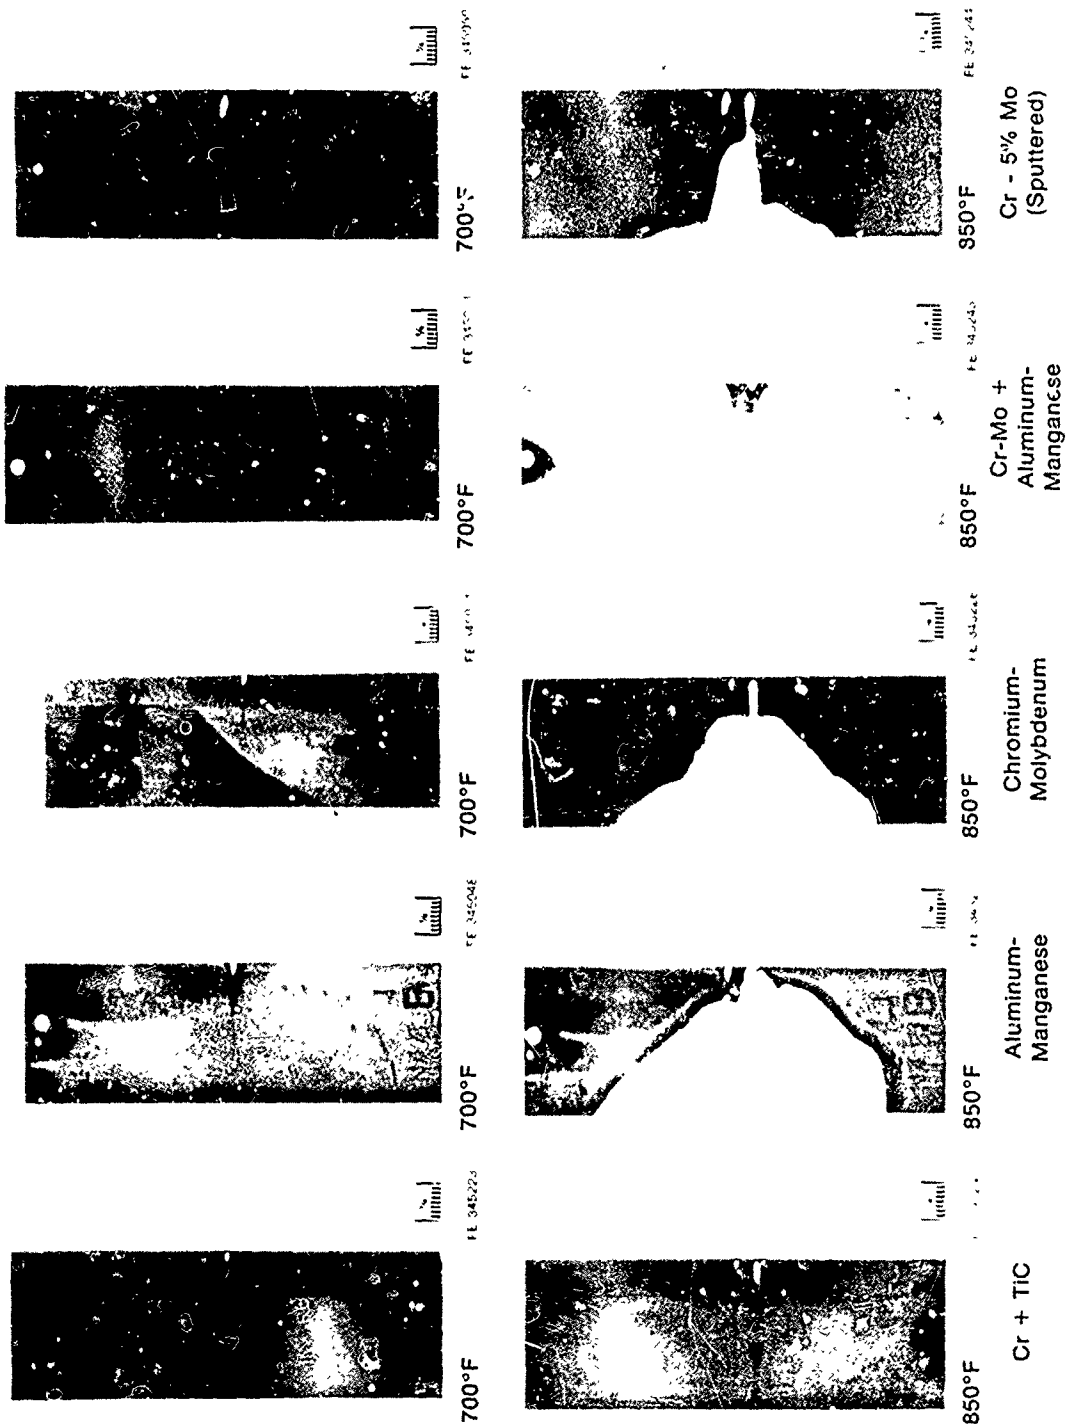
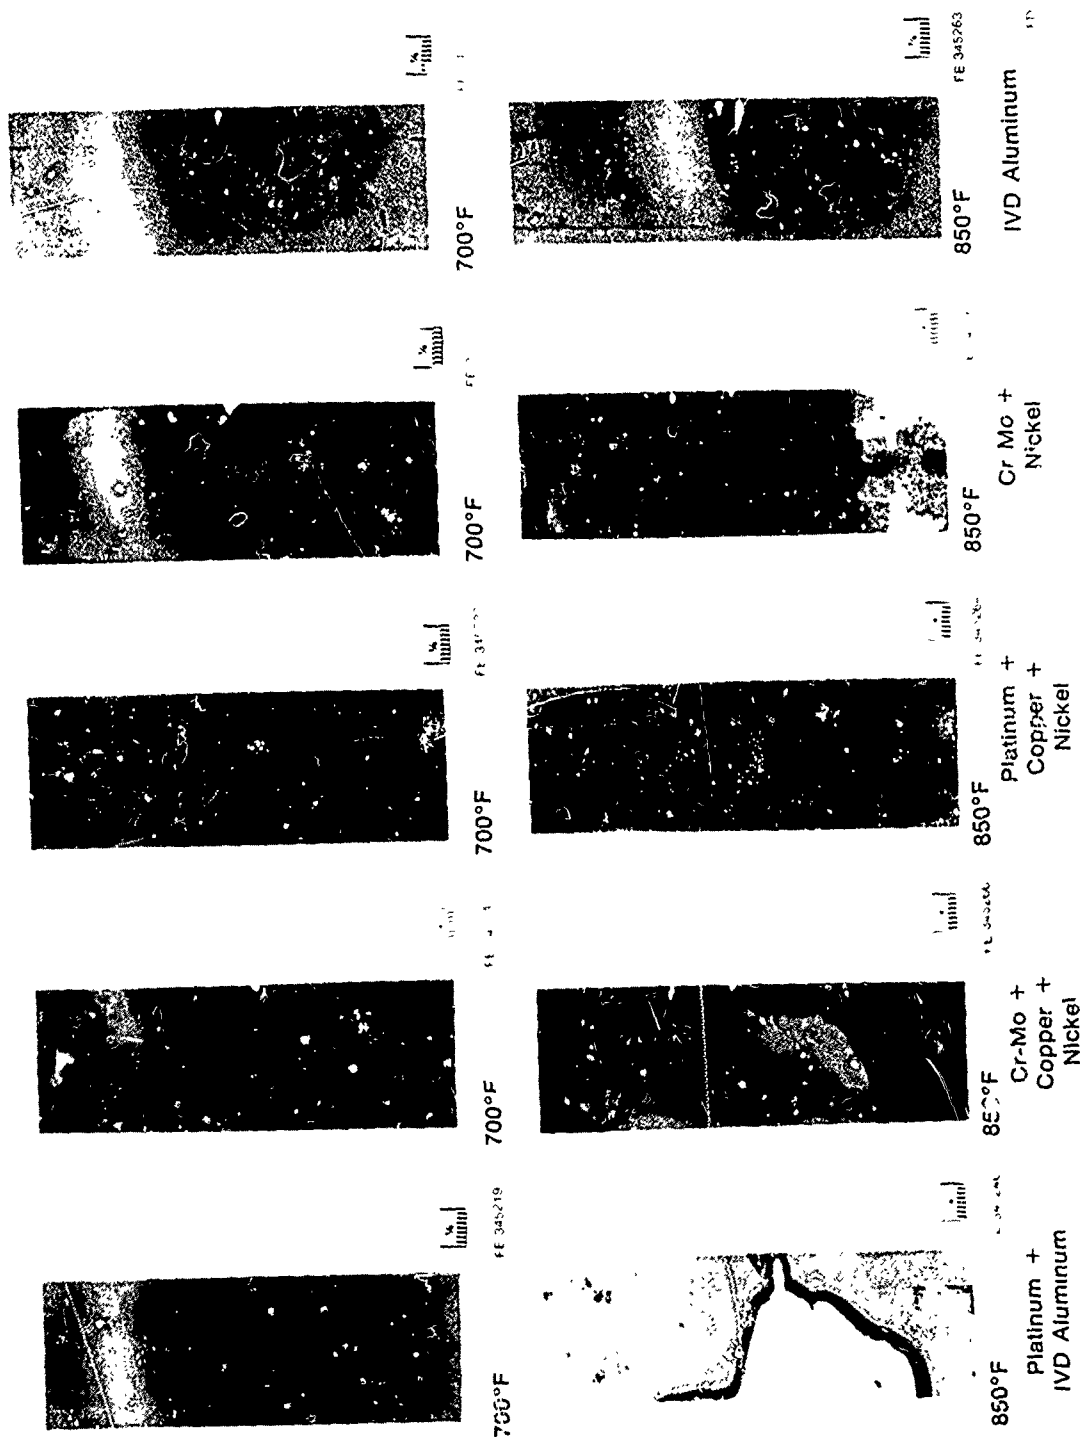
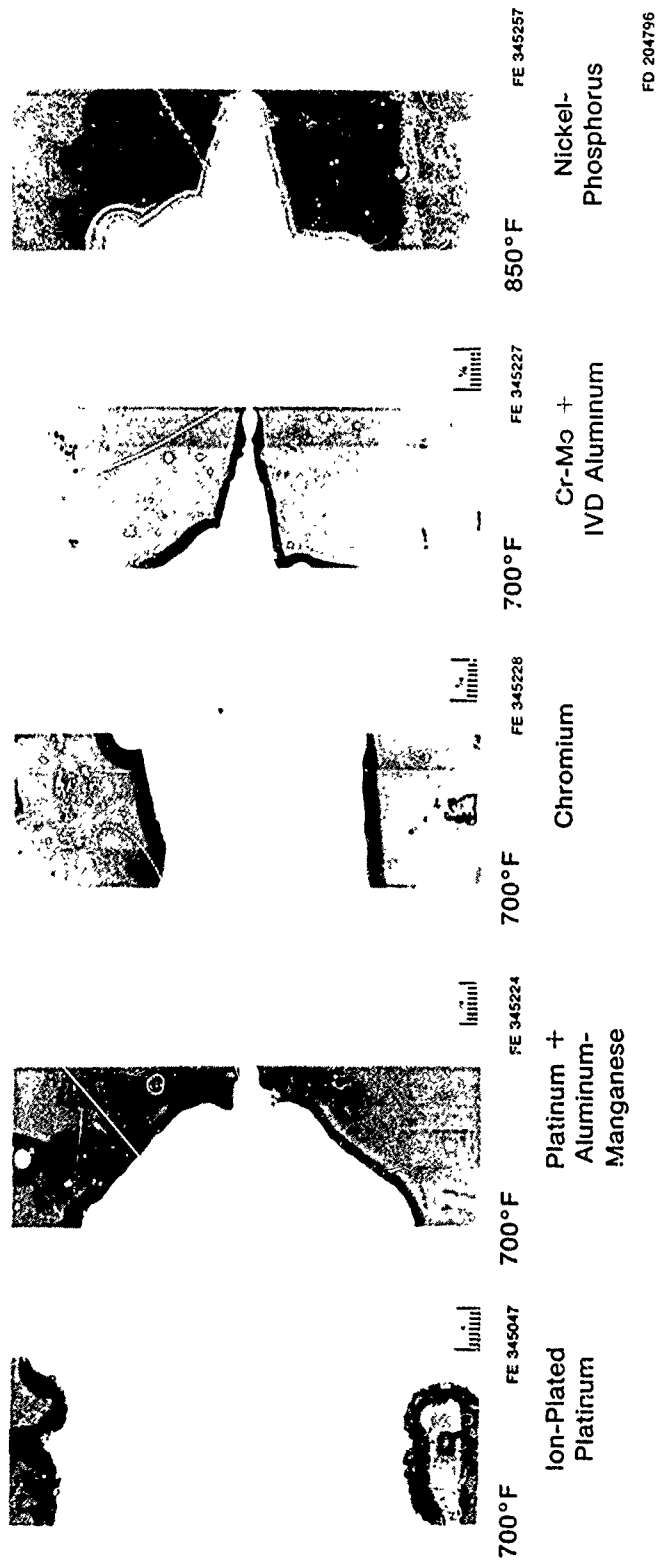
Figure 10a. Screening Combustion Test Results

Figure 10b. Screening Combustion Test Results

Figure 10c. Screening Combustion Test Results

Each coating system was applied to Ti 8Al-1Mo-1V and subjected to laser-initiated combustion testing. The initial test conditions were 700°F — 110 psia — 800 ft/sec. The specimens that did not experience sustained combustion were further tested at conditions of 850°F — 110 psia — 800 ft/sec. The results of these tests are summarized in table 1 and shown pictorially in figure 10a, b, c. After these tests, there were six specimens that did not burn; also the Cr-Mo/IVD Al burned minimally at the milder test condition. These seven coating systems

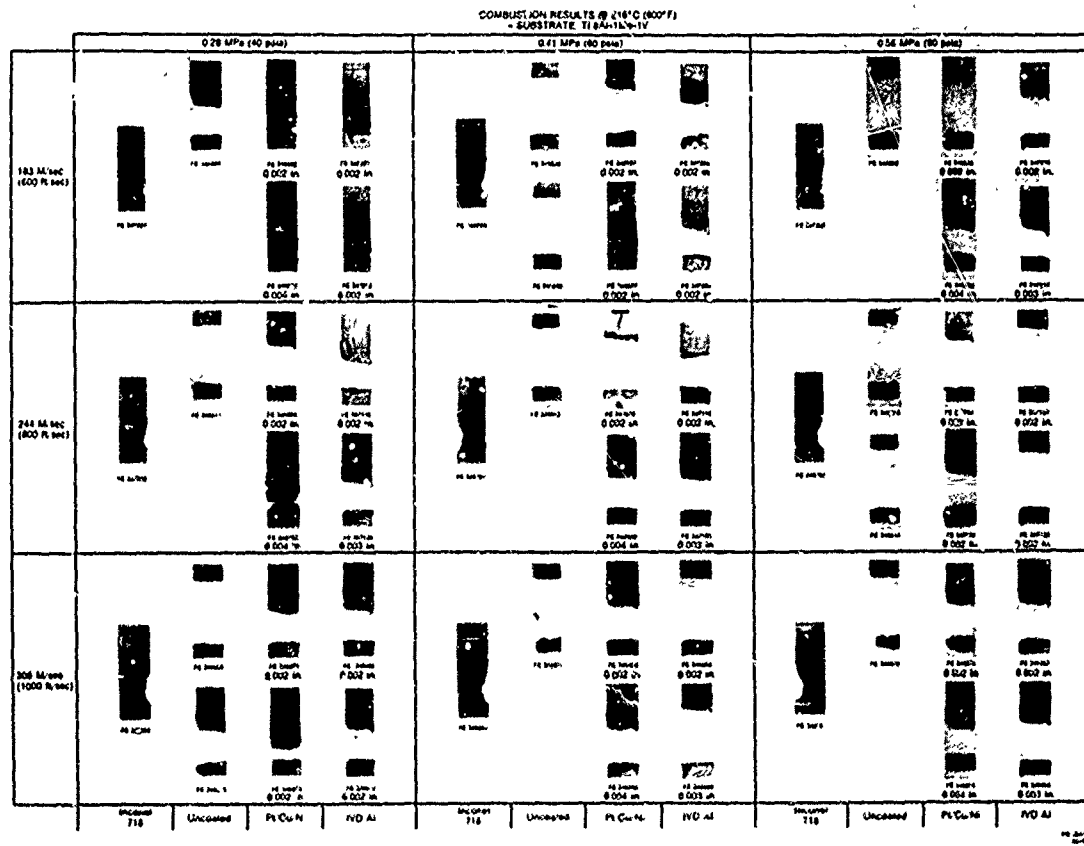
Figure 16. Cascade Combustion Test Results

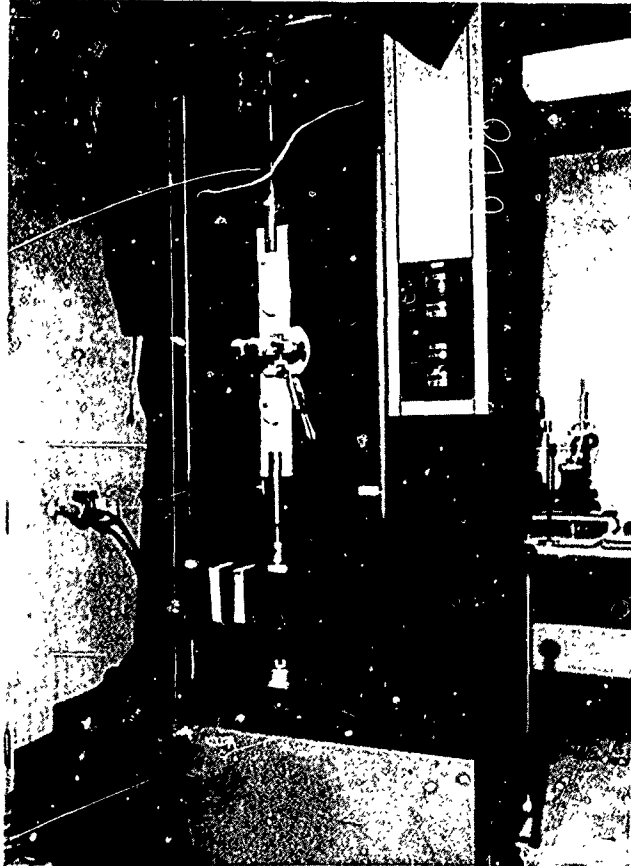
FIGURE 1. TRIPLE SLOT 7075-T6 ALUMINUM FATIGUE SPECIMEN IN INSTRON UNIVERSAL TEST MACHINE

To obtain the maximum amount of useful data with the minimum amount of machine and operator time, triple slot specimens of the configuration shown in Figure 1 were machined from 7075-T6 aluminum plate. Three through-the-thickness center slots were cut in each specimen by the electrical discharge machining (EDM) process. The use of the triple-crack fatigue specimen enabled three times as much data to be obtained per hour machine time. This was especially important at lower cycling

rates, where several days are required just to precrack a specimen. Another important advantage of the triple-crack specimen is that the control tests can be run on the same specimen with the inhibitor tests and all chance of experimental error due to variation in metal structure is eliminated.

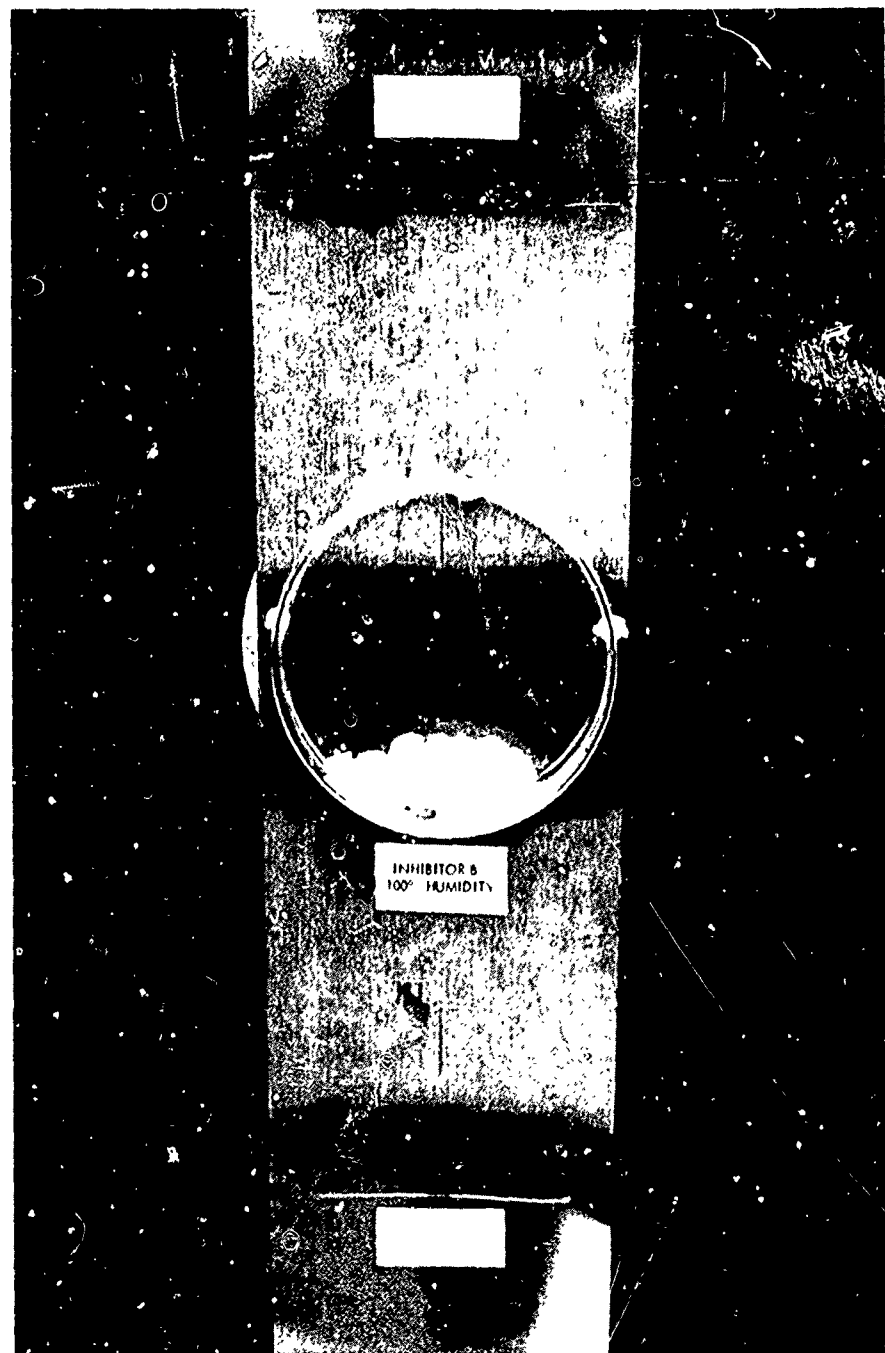
FIGURE 2. PETRI DISH CONTAINING THE VAPOR PHASE INHIBITOR IS SEALED AGAINST THE CRACK PATH.

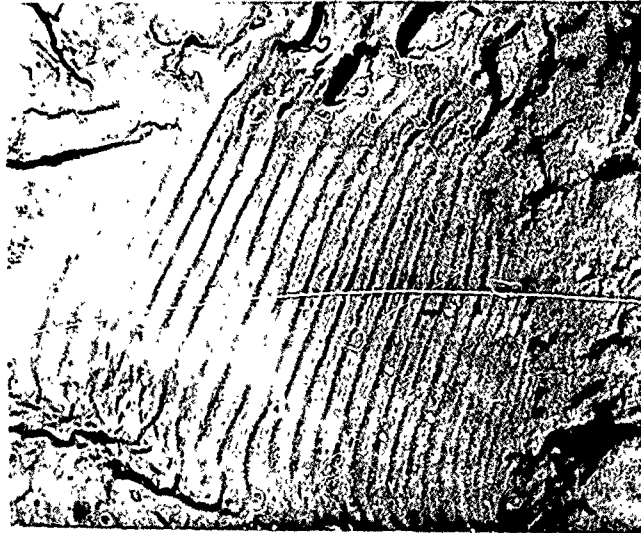
FIGURE 6. STRIATIONS IN FRACTURE SURFACE OF CONTROL SPECIMEN. CRACK GROWTH WAS 1.43×10^{-5} INCHES PER CYCLE
(10,000X)

and a specimen coated with primer which contained 5% of the L5 inhibitor. The specimens were cycled at 0.1 Hz at ambient temperature and 100% relative humidity. Figures 6 and 7 show the fracture surfaces of the test specimens. In both figures, the photograph was taken at points the same distance from the center of the crack. In the bare control specimens, shown in figure 6, the distance between striations was 1.43×10^{-5} inches. The specimen in Figure 7 was protected with primer which contained 5 percent of the L5 inhibitor. the crack growth/cycle, as indicated by the distance between striations, was 0.926×10^{-5} inch.

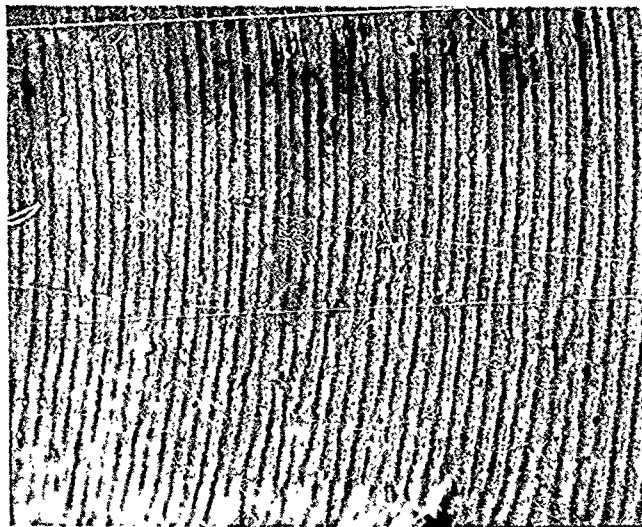
FIGURE 7. FRACTURE SURFACE OF SPECIMEN PROTECTED WITH SPECIAL PRIMER. CRACK GROWTH WAS $.926 \times 10^{-5}$ INCHES PER CYCLE.
(10,000X)

<u>Type Coating</u>	<u>Without L5 Inhibitor</u>	<u>With L5 Inhibitor</u>	<u>Percent Difference</u>
Bare	1.43×10^{-5}	1.126×10^{-5}	21.2
MIL-P-23377 with no chromates	1.04×10^{-5}	$.926 \times 10^{-5}$	11.0
MIL-P-23377 with chromates	$.788 \times 10^{-5}$	$.622 \times 10^{-5}$	21.1

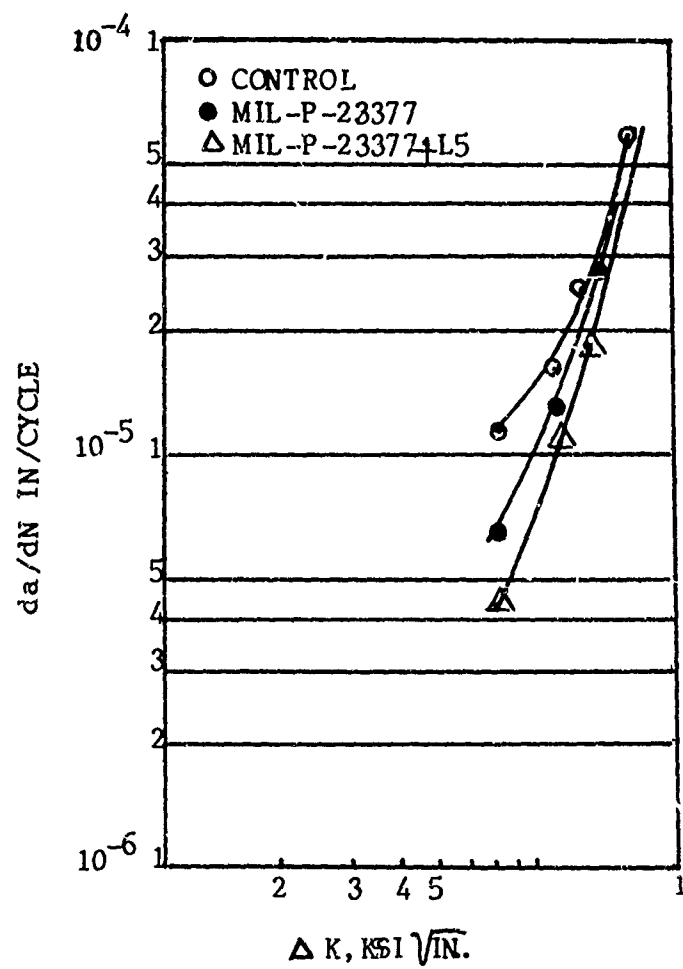
FIGURE 8. EFFECT OF MIL-P-23377 PRIMER WITH AND WITHOUT L5 INHIBITOR
(100% HUMIDITY, 0.1 HZ, $R = 0.1$)

Figure 8 is a da/dN vs ΔK plot for a bare control specimen, a specimen protected with primer only, and a specimen protected with primer which contained 5 percent of the L5 inhibitor compound. The tests were conducted at a 100 percent relative humidity, 0.1 Hz, and a stress ratio of 0.1. Comparing the two primer-coated specimens, the addition of the inhibitor to the primer resulted in a 26.5 percent decrease in da/dN at $\Delta K_I = 7$ and a 15.4 percent decrease at $\Delta K_I = 10$.

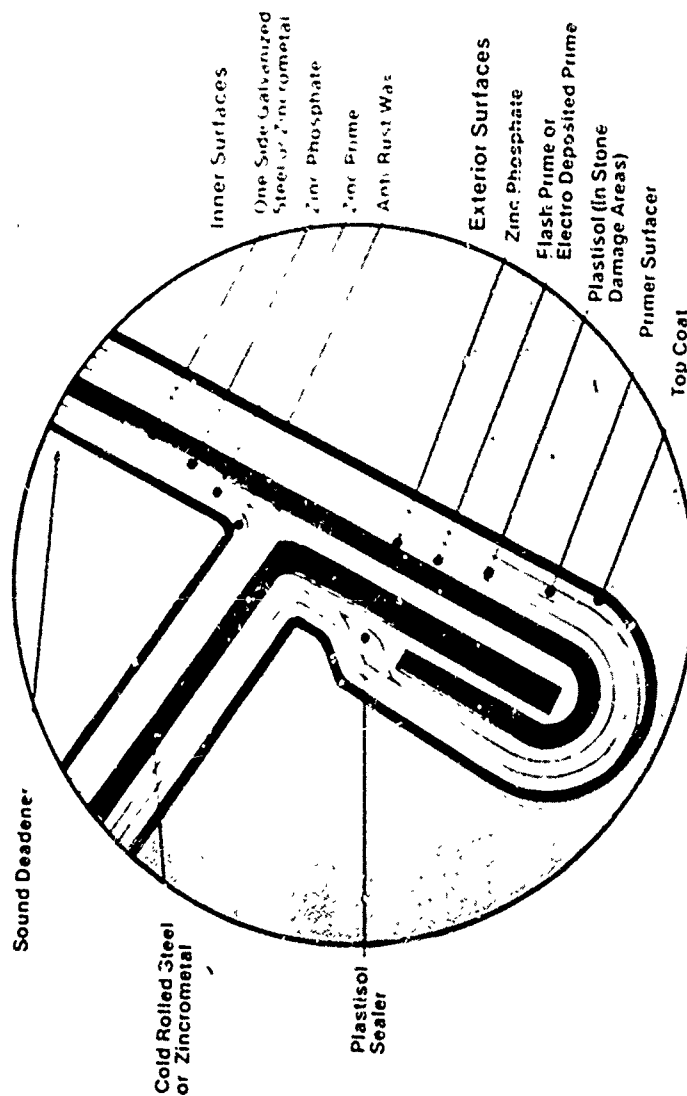
Figure 10:

Post assembly coatings provide improved protection against corrosion. Here, the door outer panel is of one side galvanized steel with three additional coatings on the inner surface and five, including topcoat, on the exterior surface. Deadener also is applied to the inner surface of the outer panel.

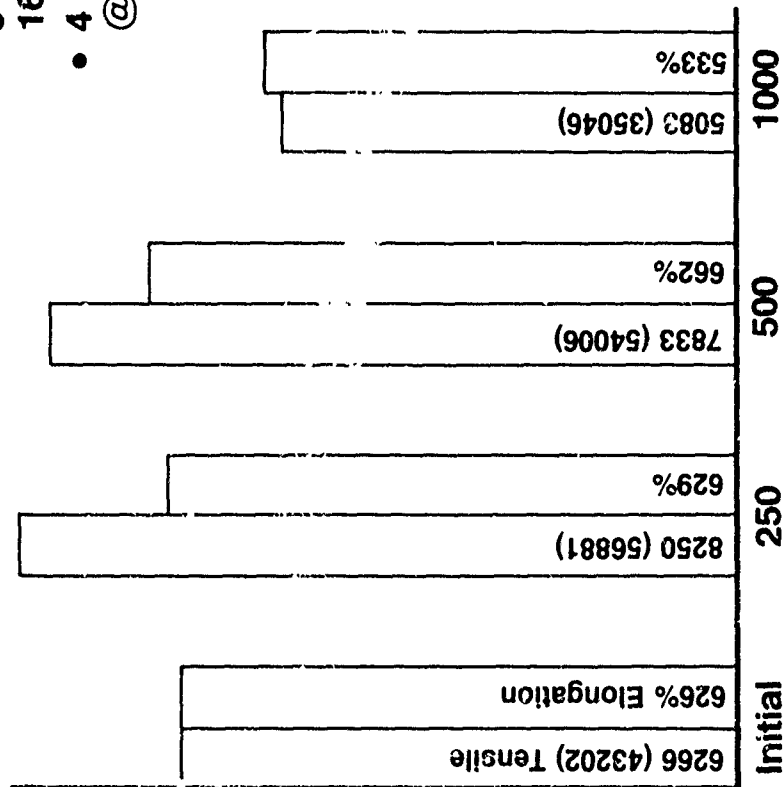
Illustration 11.

QUV Cycle

- 8 hrs. UV @ 160°F (71°C)
- 4 hrs. Condensation @ 120°F (49°C)

QUV — Hrs.

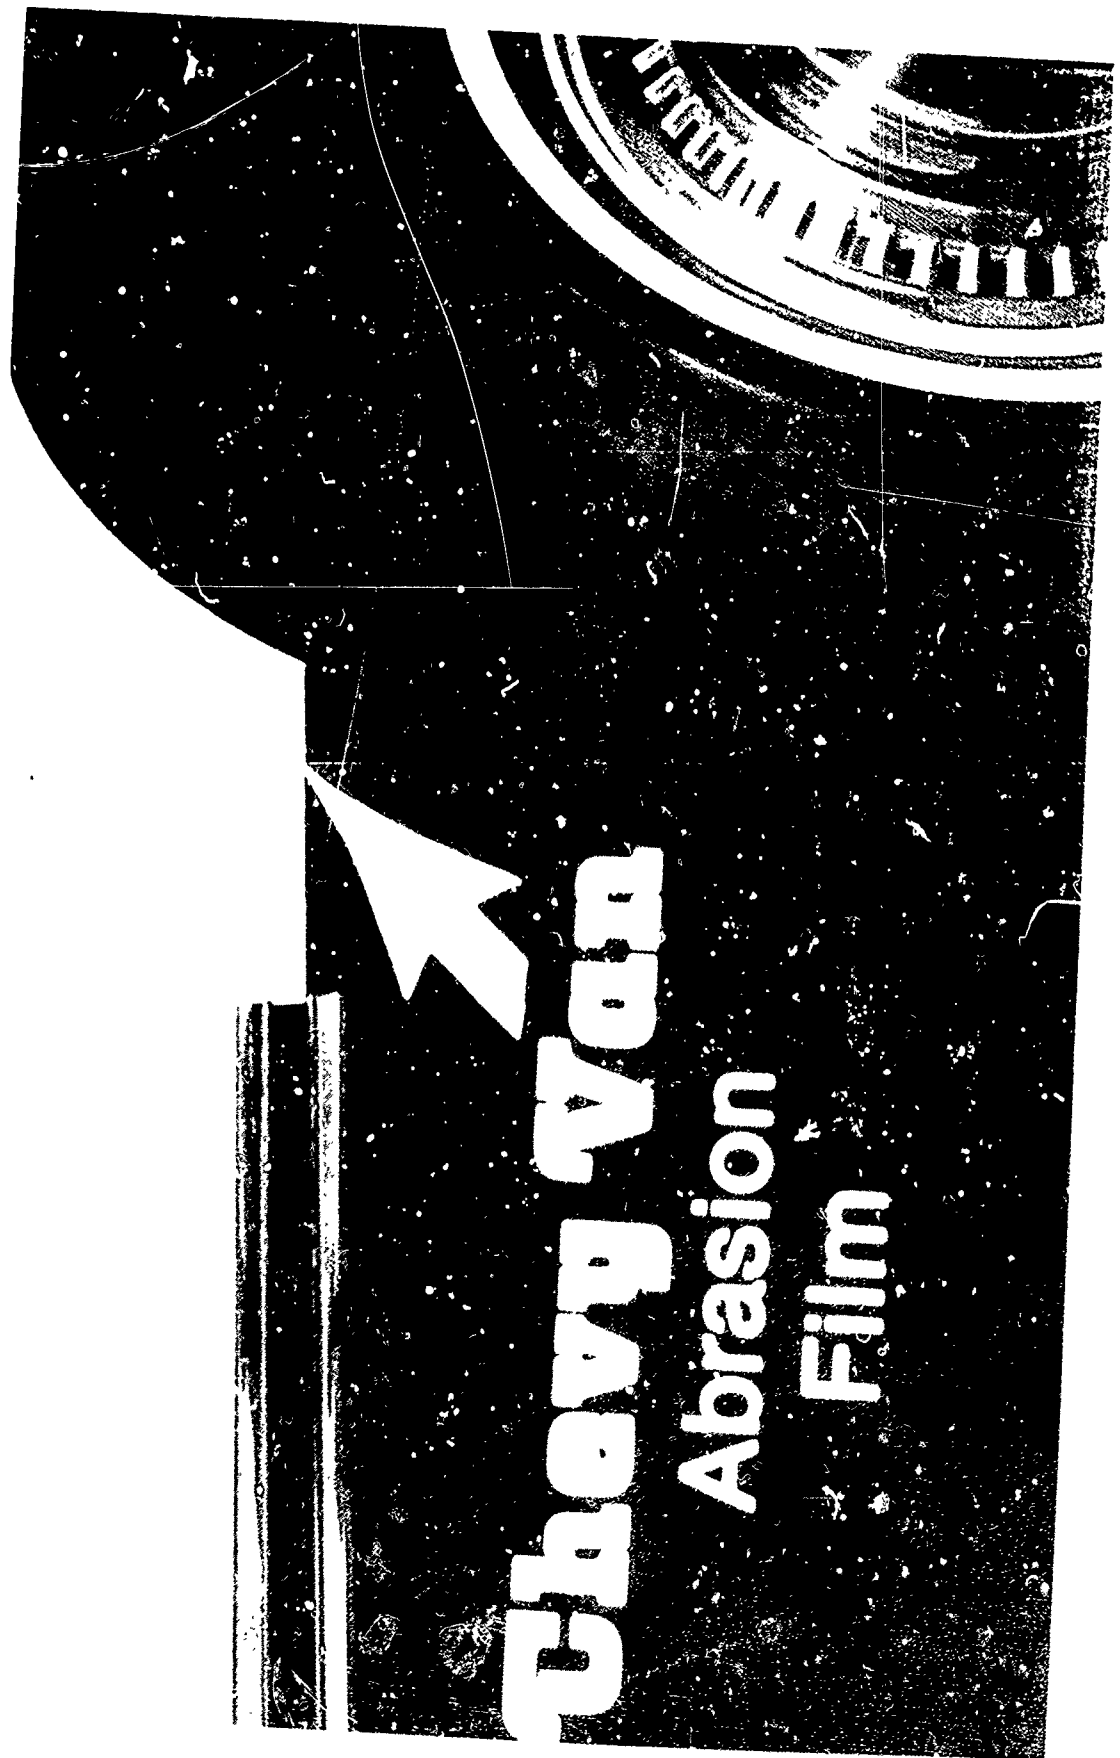
Illustration 22.

FILLER PANEL ABRASION PROTECTION

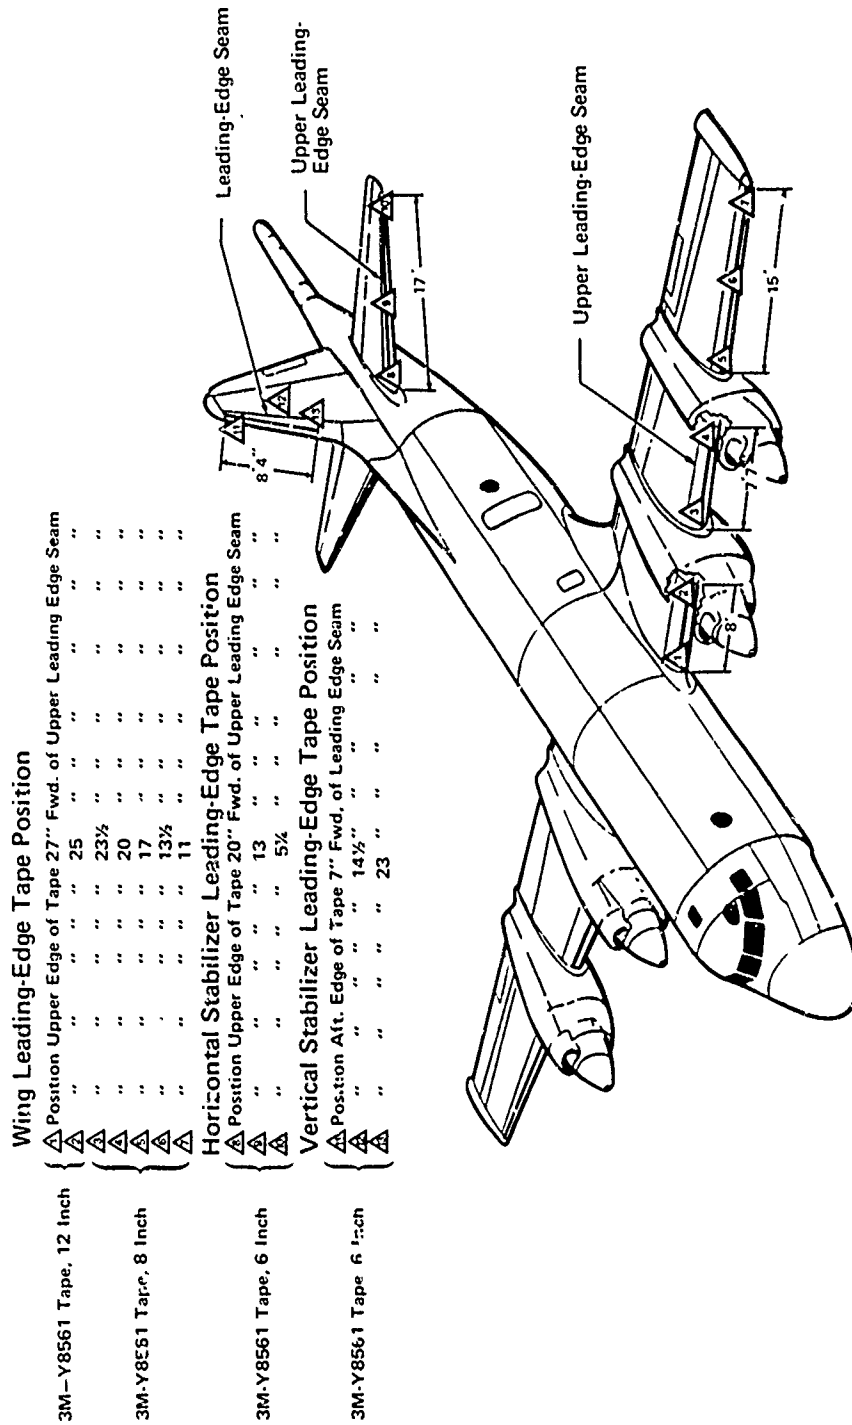
Illustration 27.

P3 LEADING-EDGE TAPE INSTALLATION

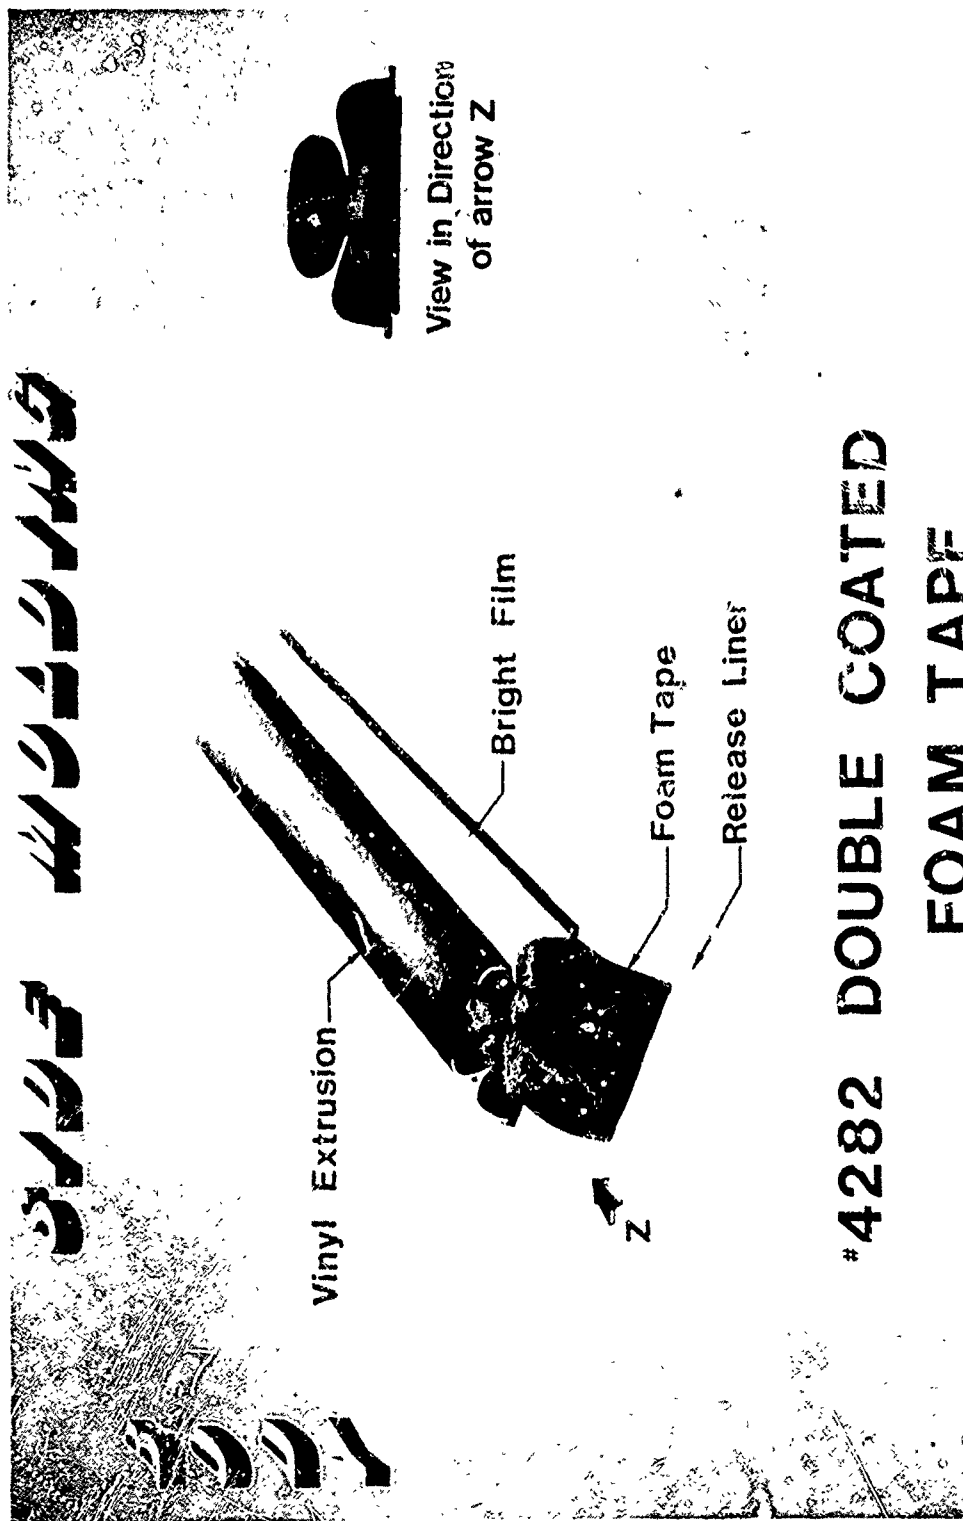
Illustration 33

#4282 DOUBLE COATED FOAM TAPE

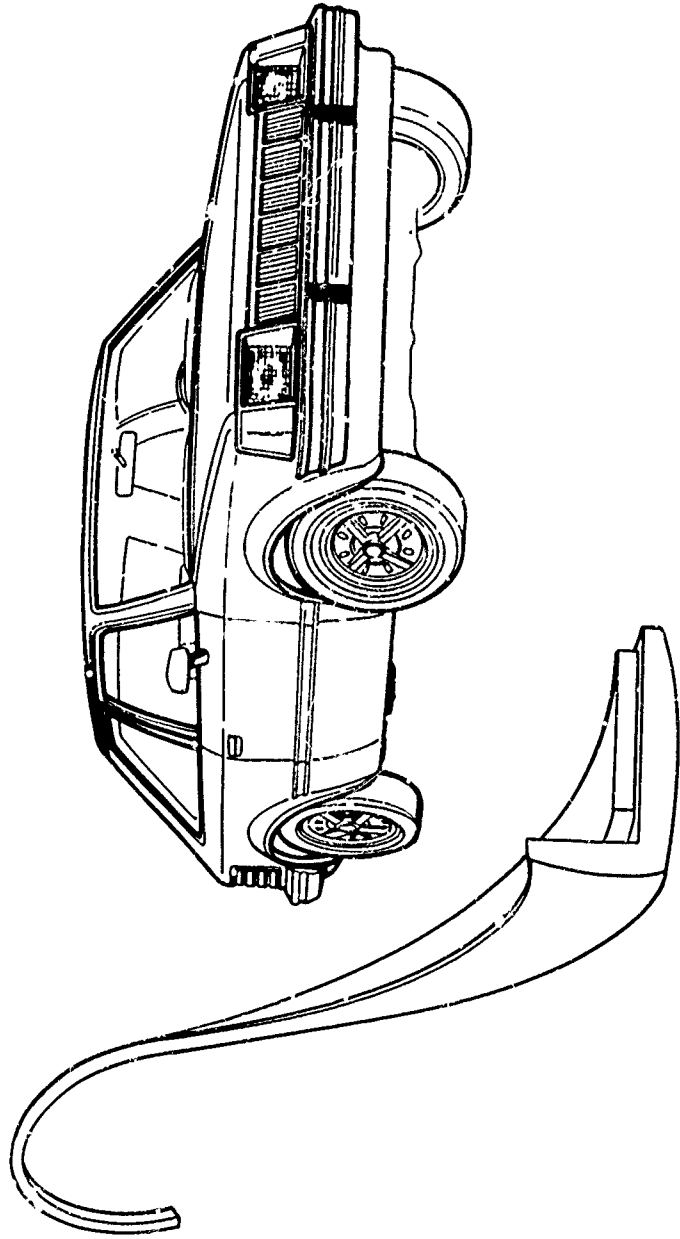
Illustration 41.

Wheel Lip Molding

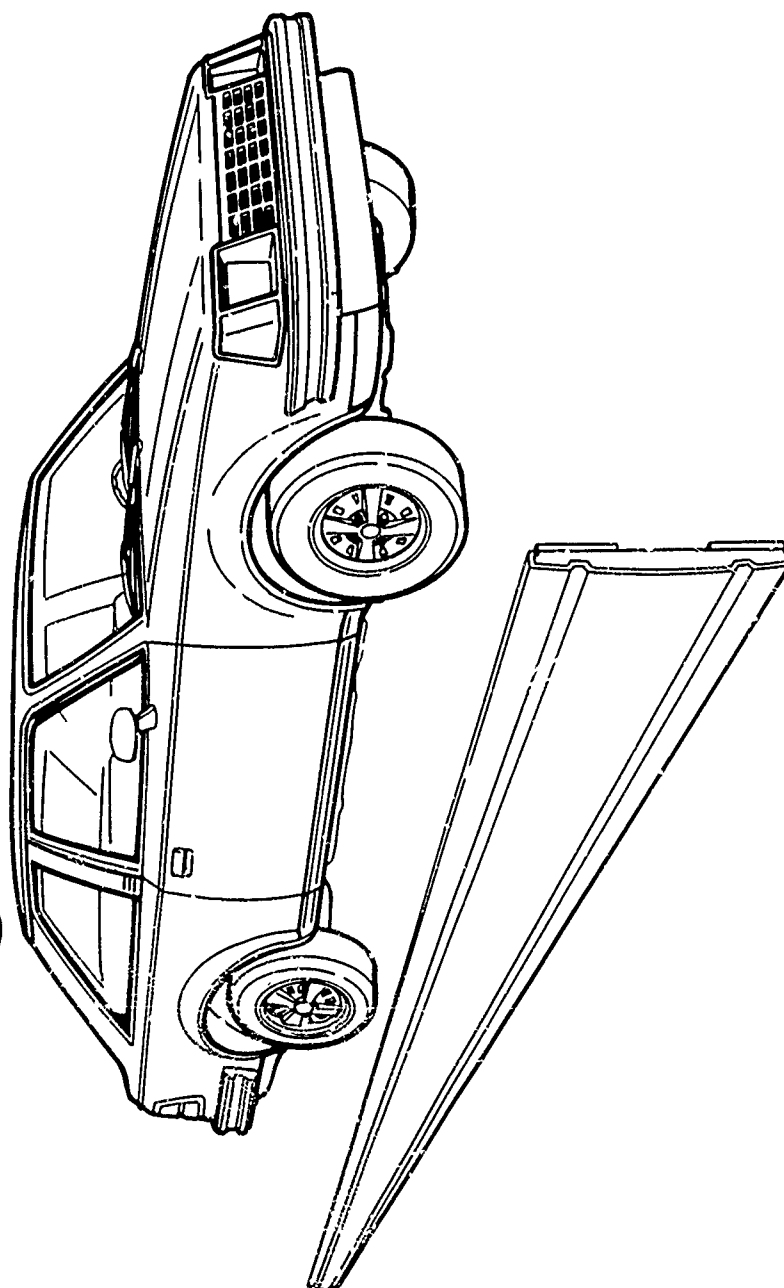
Illustration 42.

Lower Body Molding

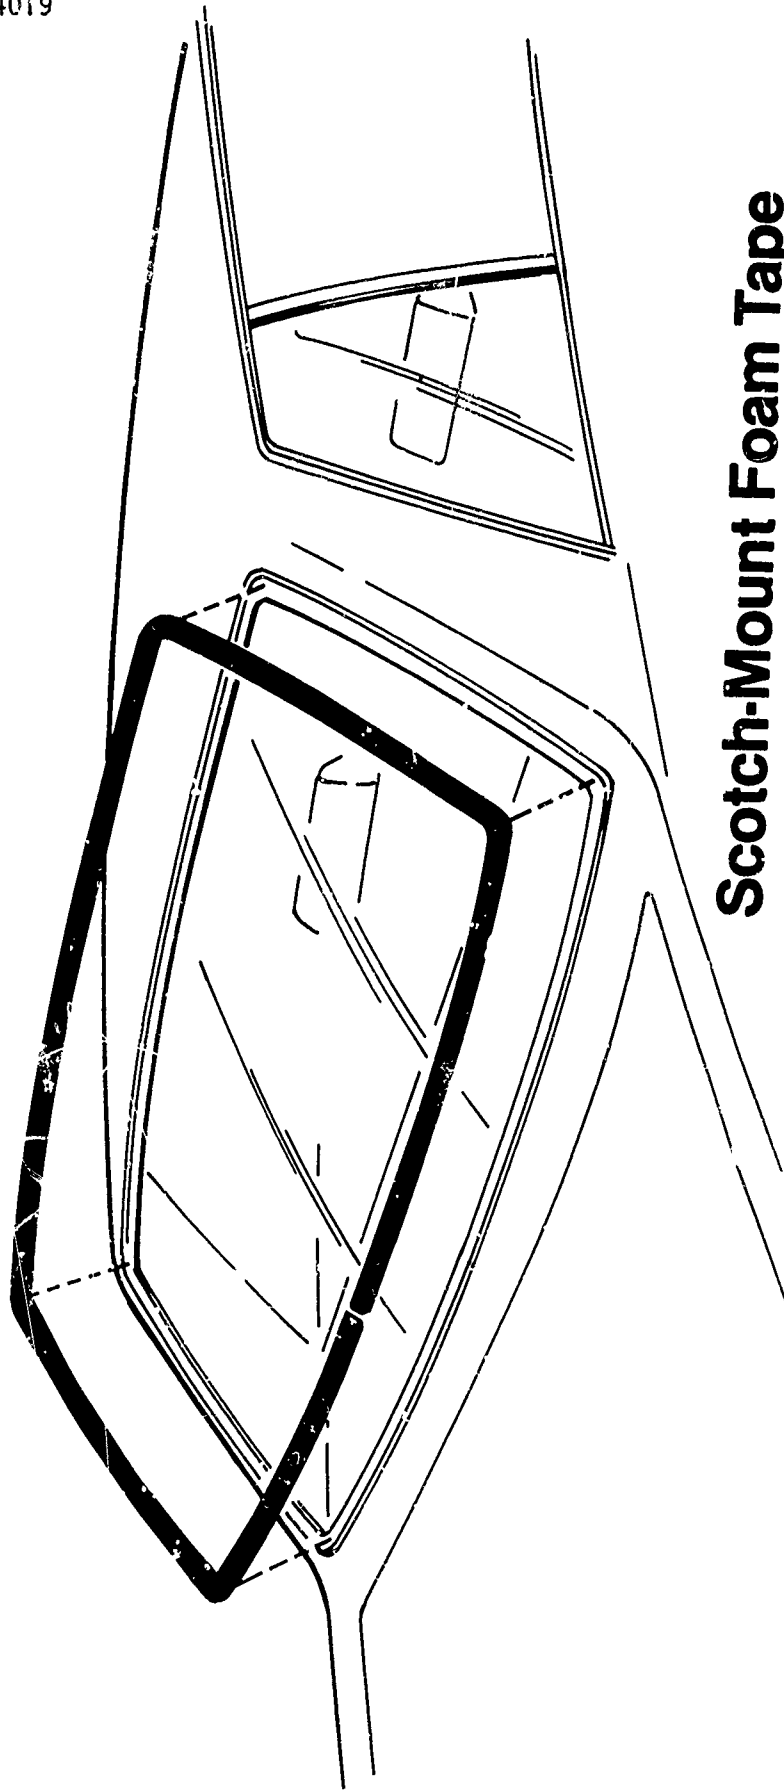
Illustration 43.

Reveal Moldings

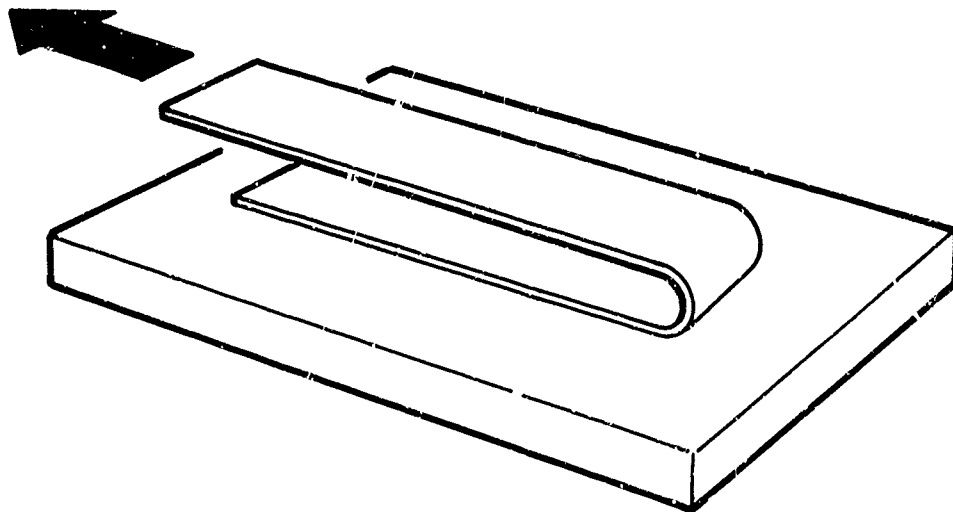
Illustration 44.

Adhesion Test

Peel

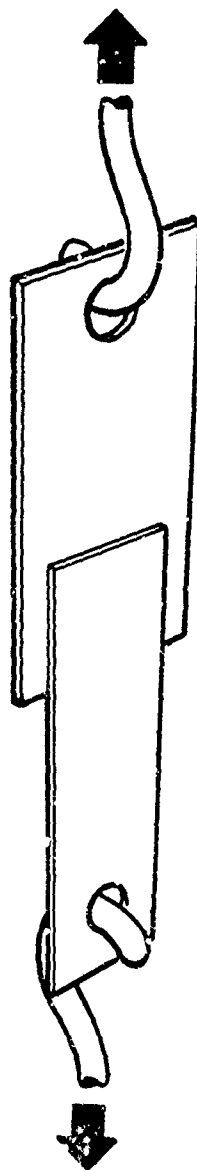
Illustration 46.

Adhesion Test

Dynamic Shear

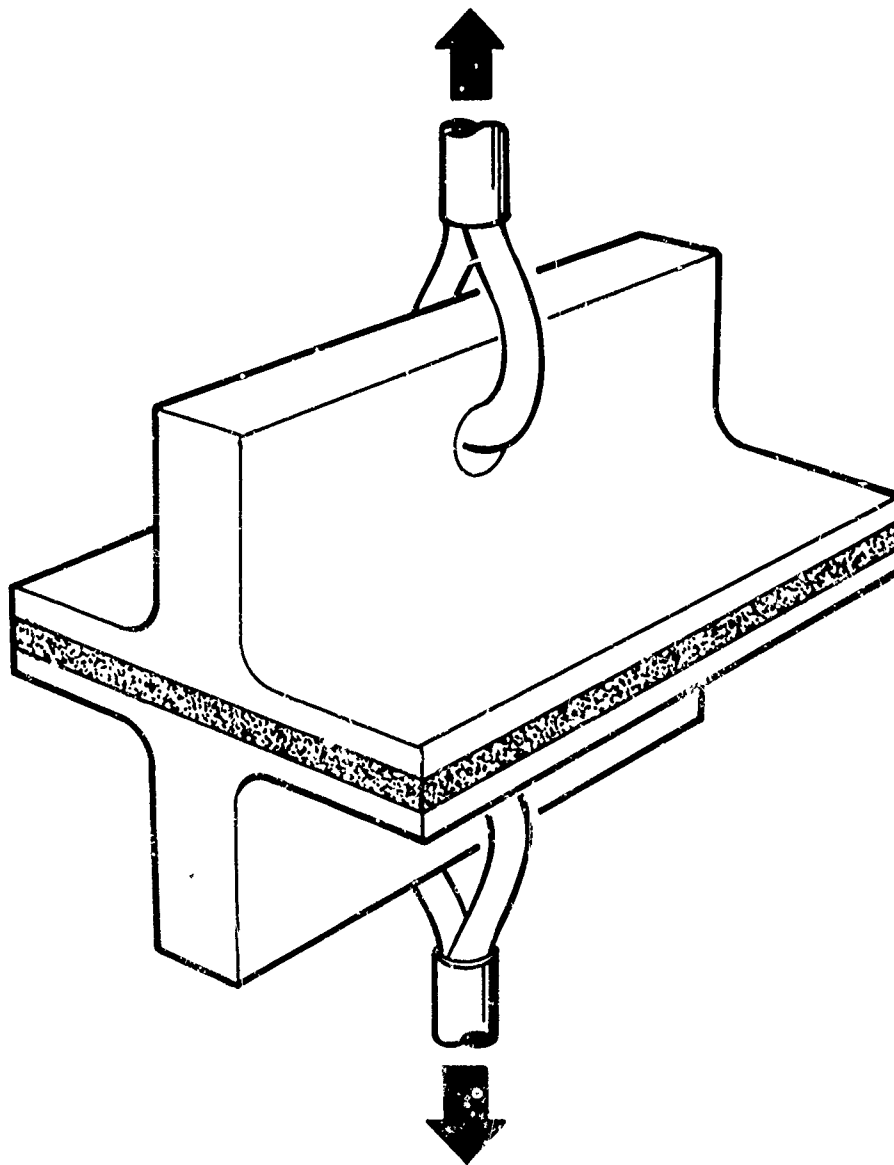
Illustration 47.

Adhesion Test

Tensile (T-Block)

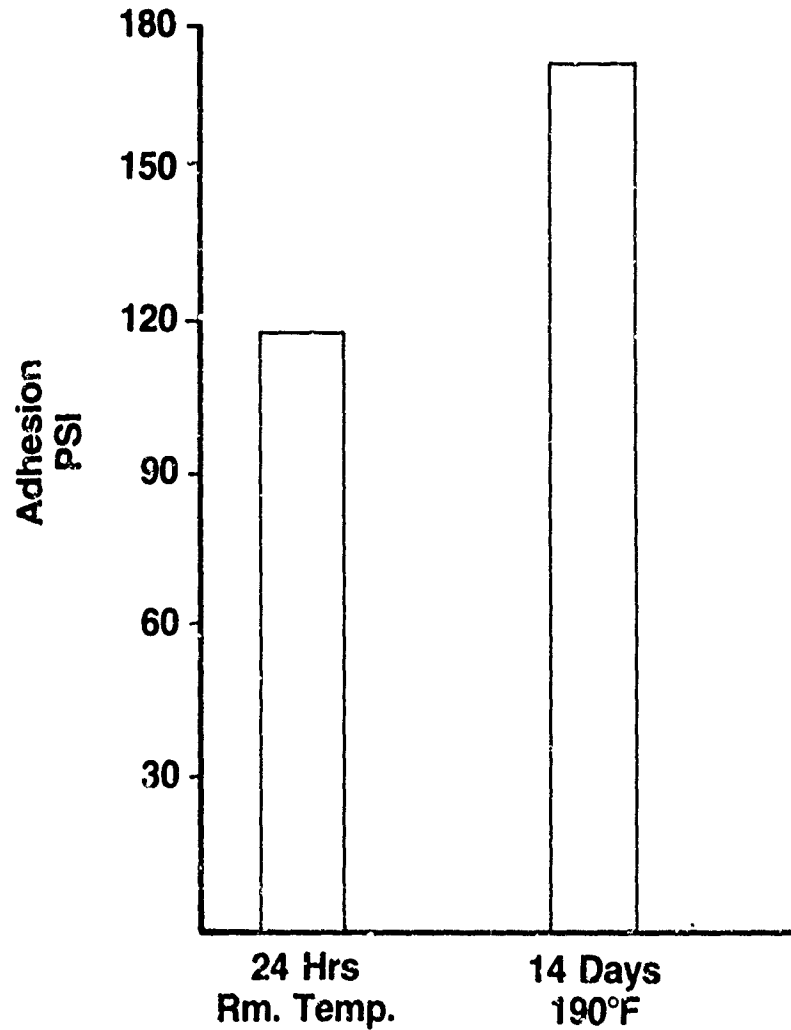
Illustration 48.

Dynamic Shear .045" Neoprene

Surfaces: Aluminum to Enamel Paint

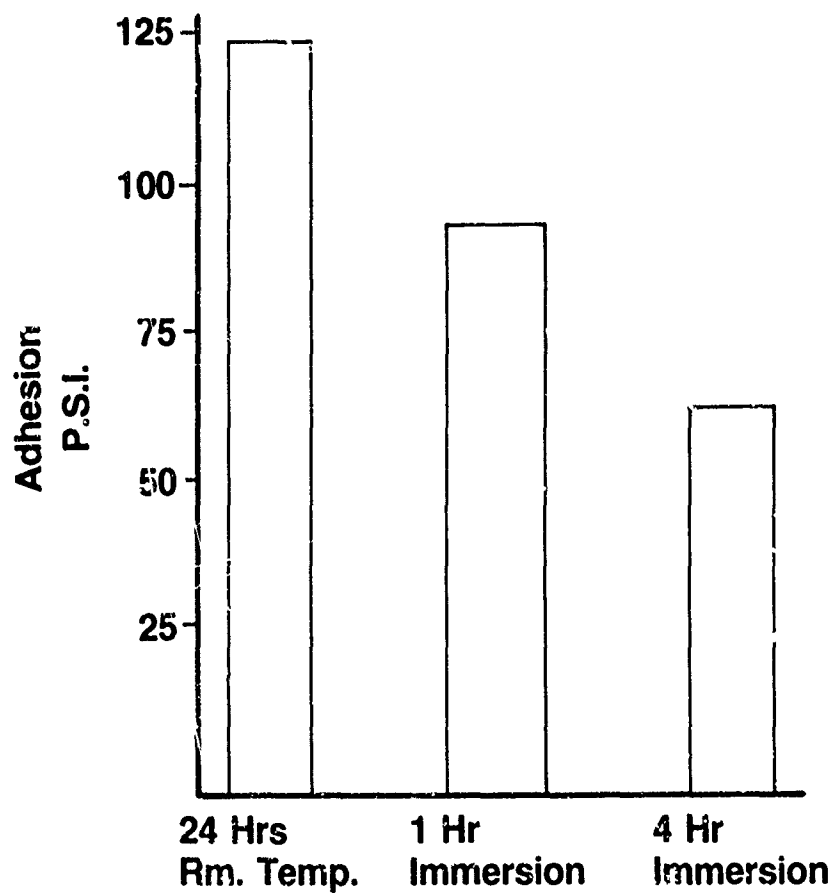
Illustration 49.

Dynamic Shear .045" Neoprene 10% Gasohol Immersion

Surfaces: Aluminum to Enamel Paint

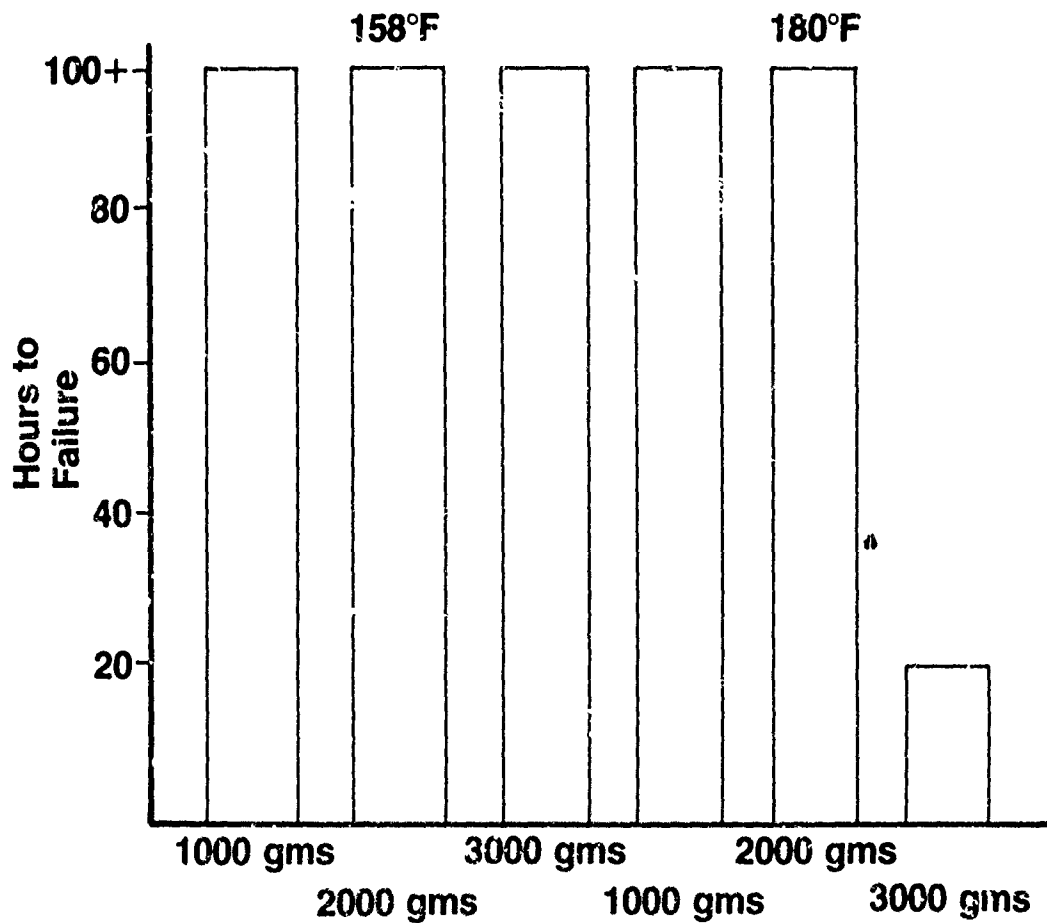
Illustration 50.

Static Shear .045" Neoprene

Surfaces: Aluminum to Enamel
Test Terminated at 100 Hours
